# ROOT CAUSE ANALYSIS

## WINDOWS FAILURE

**VESSEL** : ERLA KONGSDÓTTIR  
**IMO** : 9905526  
**DNV GL id** : 40921  
**CASE NO.** : 38359  
**DOCUMENT NO.** : 1353-515-011-A

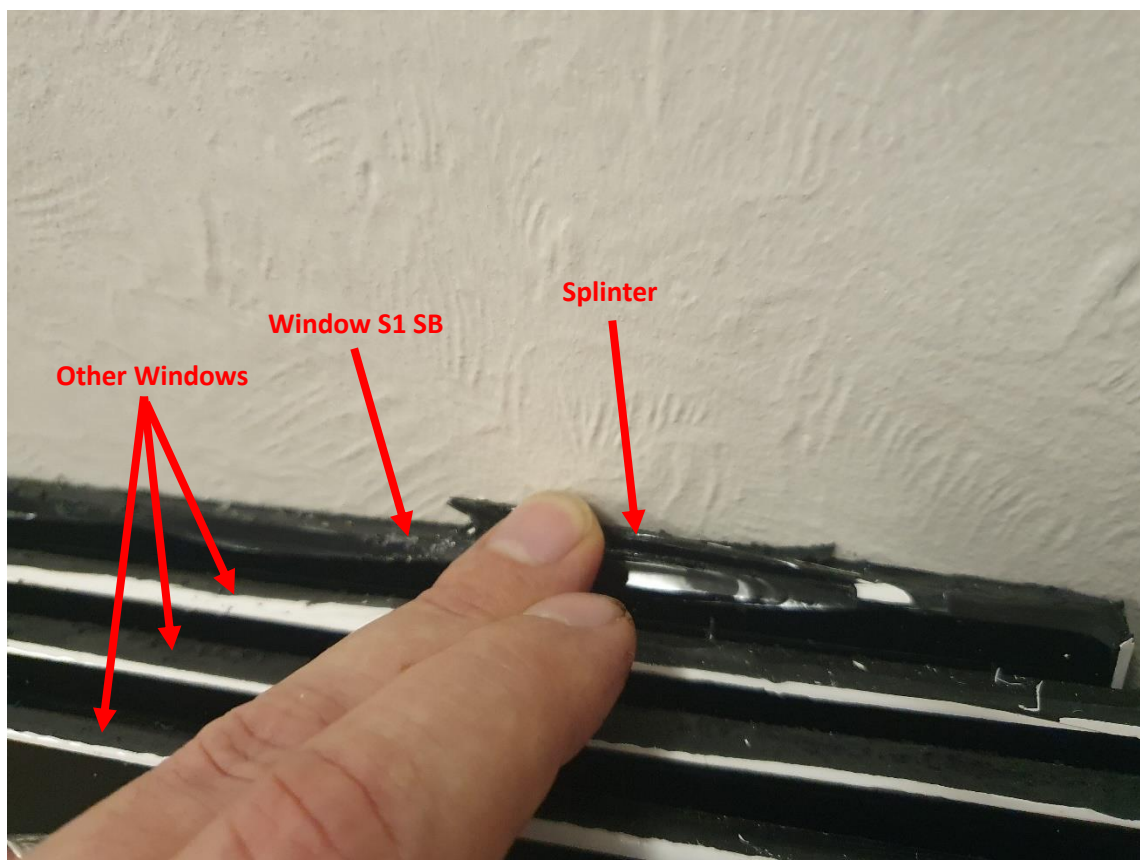
We did however notice that there was some damage to the upper edge of one of the windows, shown in this photo:

As already mentioned, there was clear damage to the edge of at least one of the glasses that were removed in December 2020.

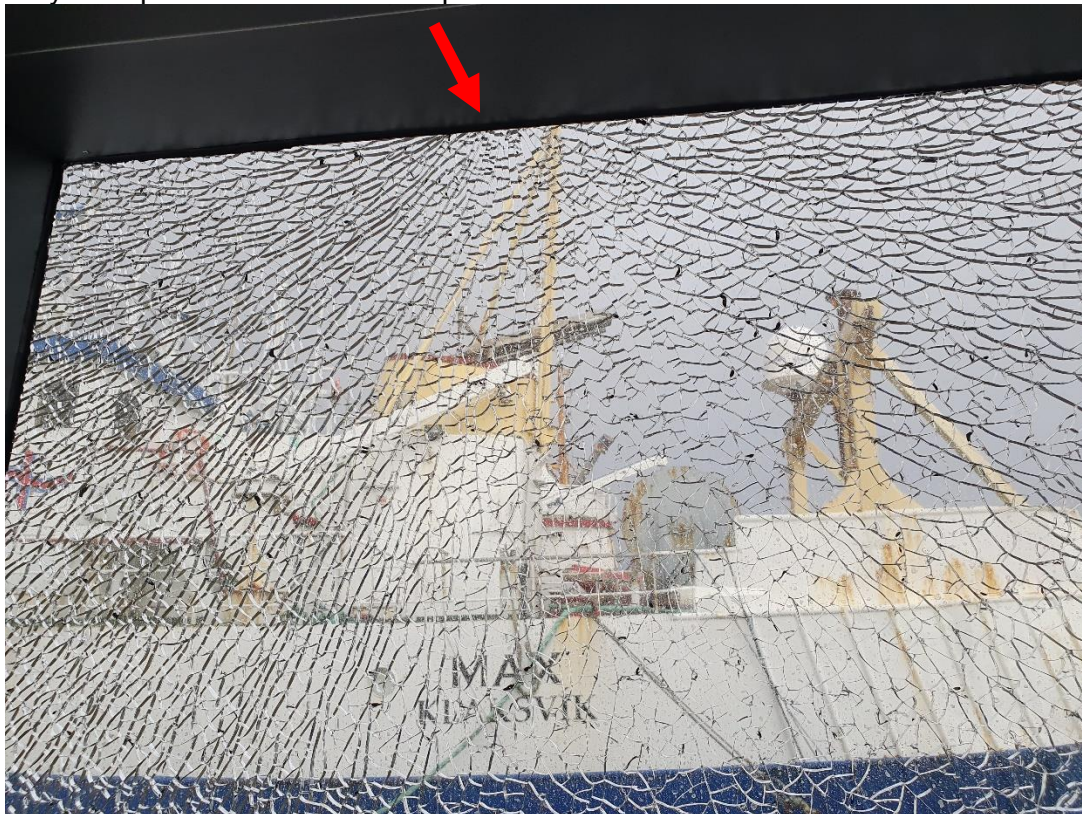
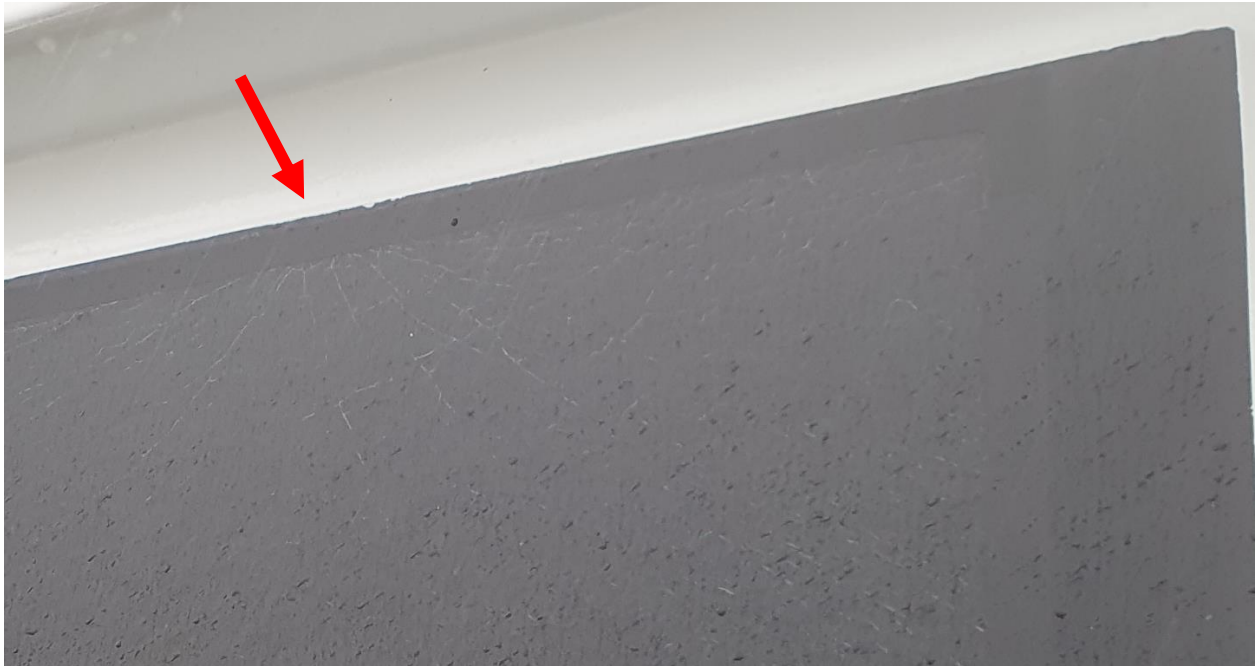
After the first two windows broke in December, a laminate was installed on the inside of the remaining windows, to ensure that in case another window broke, splinters would not fall onto any passengers. This laminate also enabled us to see the window that broke in February in its place after it broke. Se pictures:

It is clear that the initial fracture was from the top edge, and all the remaining fractures propagate out from there.

With the shape of the fractures in mind, it looks like the windows had damages and/or imperfections on the edges from the start. And combined with a lack of joint flexibility and possibly hull flexibility, the tension on the glass surpassed what the damaged parts of the windows could withstand, resulting in a shattering of the glass.

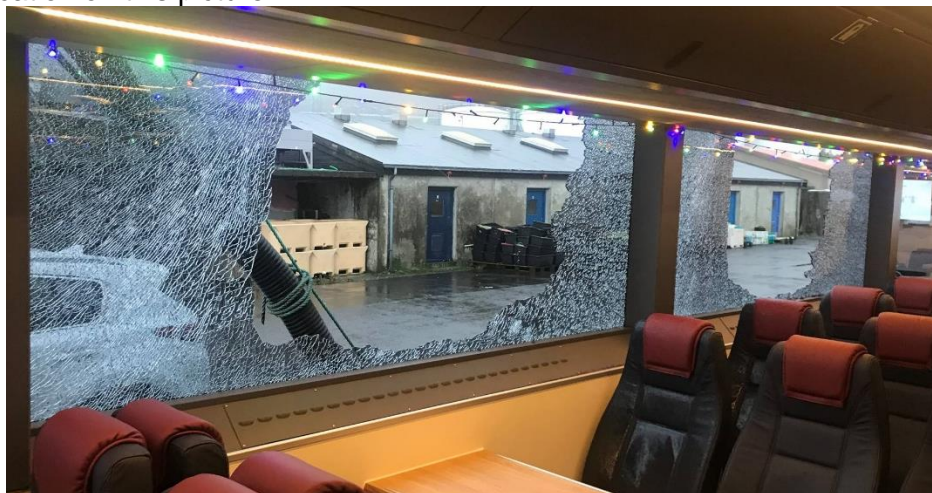
The windows that broke in December did not have a laminate inside, so part of the window fell down when it shattered, making it harder to see the form of the cracks. But there is the same indication on this picture:
